Customer case study

Diagnostic test equipment

HYCO

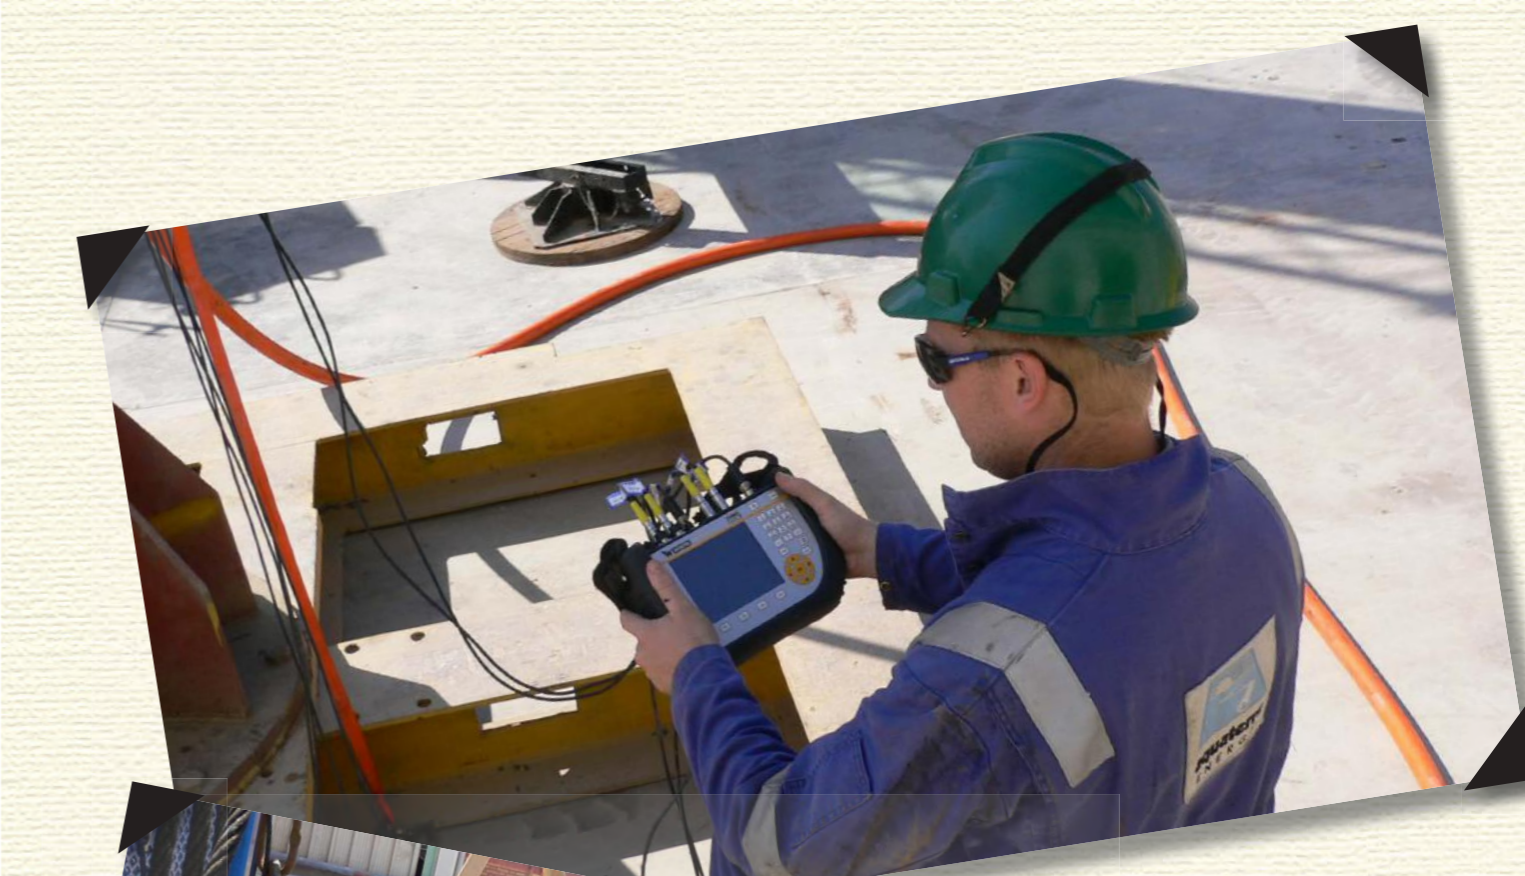
HPM6000 in use

The HPM6000 turned out to be as simple to operate as the average mobile phone, the graph readouts were clear and simple to understand, the battery only needed to be recharged once in three days of testing and, despite the fact that the work was conducted in bright sunlight, the equipment screen was clearly visible.

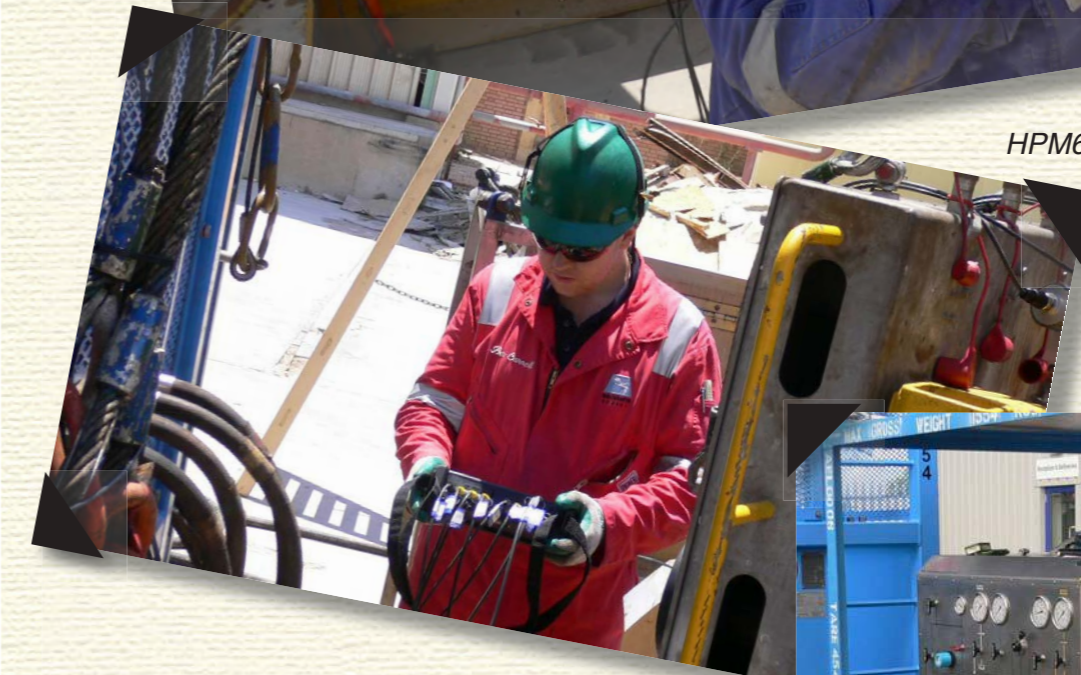
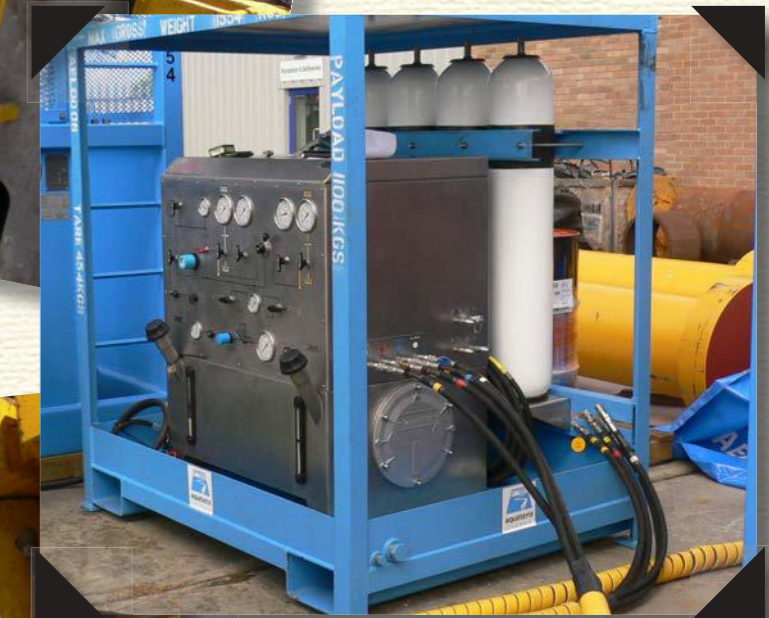
Hyco's Hydraulic Power Unit (HPU)

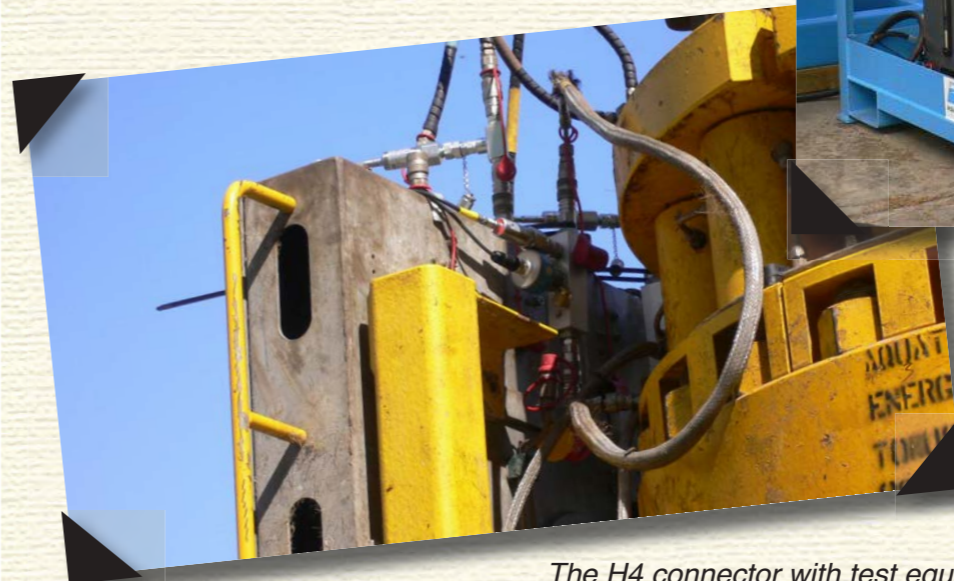
The H4 connector with test equipment attached

A few weeks later, Hyco was in possession of a hire kit with sensors which had the capability of measuring two flows, six pressures and six temperatures. Despite only having had an hour or two to get to know his way around the Webtec product, software and menus, a representative from Hyco Ltd was soon back in Egypt where he was able to quickly establish that the fault did in fact lie with the connector.
